## THEFT DETECTION DEBT – DE-ENERGISED – DETECT

*Mercia Utility Services Ltd*

### The link between Debt Warrant and Revenue Protection

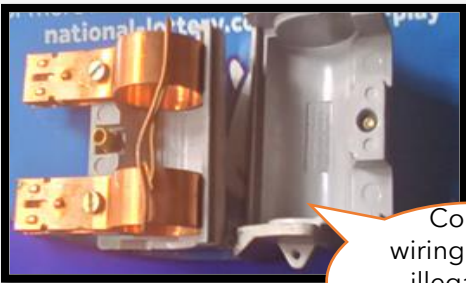
The most common tamper technique discovered with a de-energisation is a substitute fuse replacement. This tamper can result in voltage overload where the fuse can melt and can ultimately lead to a fire hazard!

Copper wiring used to illegally re-energise meter

The fuses, which has been removed on the Debt Warrant, had been replaced with copper wiring to re-energise. The fuses were hot to the touch, and it was deemed a high Health & Safety threat. The DNO engineer removed the meter and tails. They then arranged for an additional third party to proceed to pot-end the supply. Two engineers arrived and dug up the pavement right outside the property. They cut the live supply cable and removed power from site. The site now has no electric supply or meter. The DNO put barriers around the hole and will come back to site to seal the hole on the pavement.

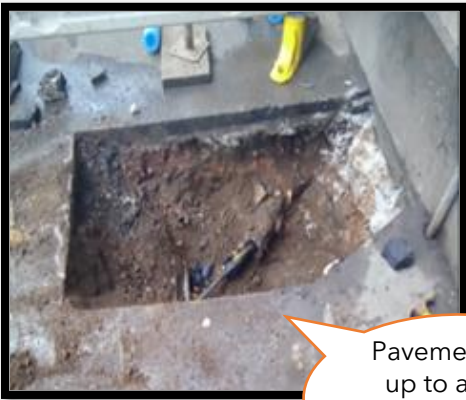
Pavement dug up to access live cable supply
